Manhole Inspection Summary

Manhole # S150__003MH

Insp Date: **3/27/08 12:28 PM**

Location Address: **2643 DULANY ST**

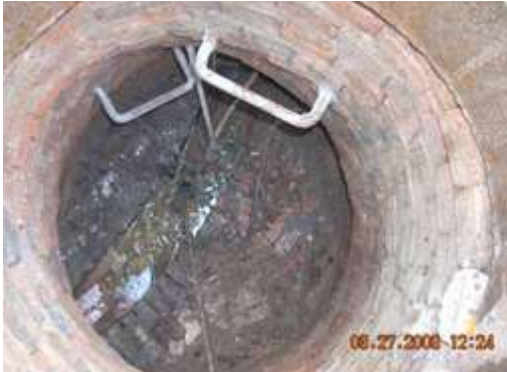
misc

bench debris

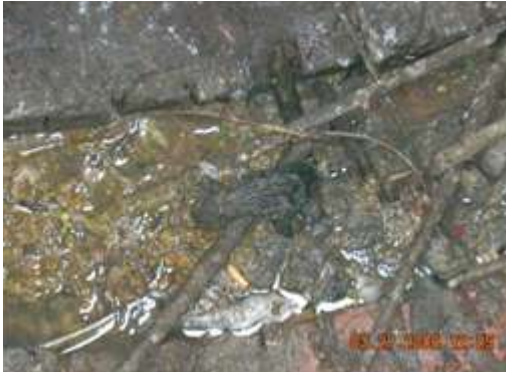
Defect 3

Condition: ☐ Sound ☐ Cracked ☐ Root Intrusion ☒ **Deteriorated** ☐ Leaks ☒ **Debris**

DEBRIS IN CHANNEL

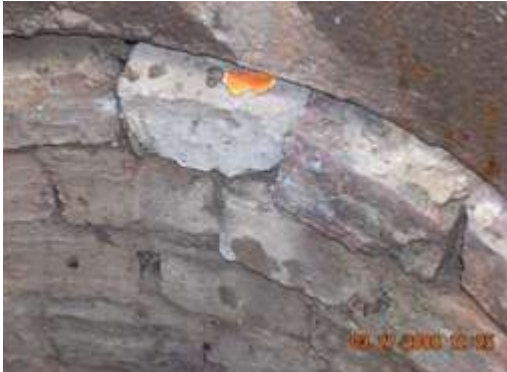
Defect 2

Condition: ☐ Sound ☐ Cracked ☐ Root Intrusion ☒ **Loose Brick** ☐ Deteriorated

LOOSE CORBEL BRICKS

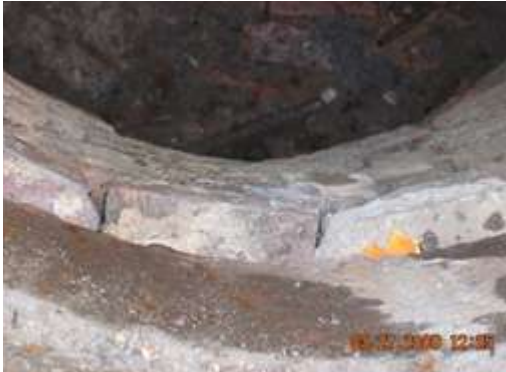
Defect 1

Offset: **1** (in.)

FRAME OFFSET

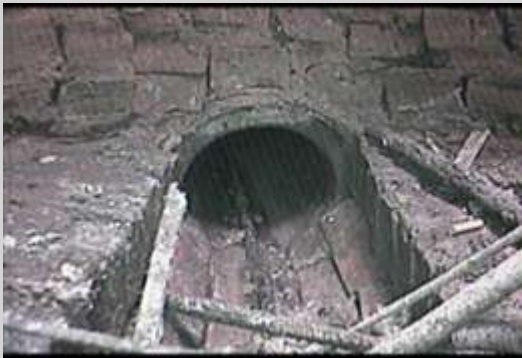
12 O'Clock Outflow

Pipe Height: **8.4** (in.) Rod and Bar (Angled)
Pipe Material: **Clay** ☐ Pipe Lined
Invert Depth: **6.88** (ft.) Flow Characteristics: **None**
Deposits: ☐ None ☐ Mud ☐ Sludge ☒ **Debris** ☐ Grease
Silt Depth: **1** (in.) Deposits Extent: **Light**
Infiltration: **None** Pipe Seal Cond: **Sound**
